Manhole Inspection Summary

Manhole # S41AA_012MH

Insp Date: **11/11/08 2:36 PM**

Location Address: **1500 e monument st**

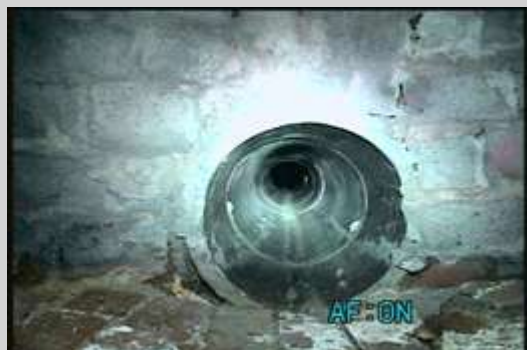
12 O'Clock Outflow

8 in. Circular Gravity Sewer
Pipe Out @ 12 O'Clock

Pipe Material: **Clay** ☐ Pipe Lined

Infiltration: **None** Pipe Seal Cond: **Unknown**
